DAMAGE ASSESSMENT FORM

Building Name KROME RESIDENCE

Address 17845 S.W. 296 STREET

City (or Vicinity) and County DADE COUNTY. MIAMI, FL

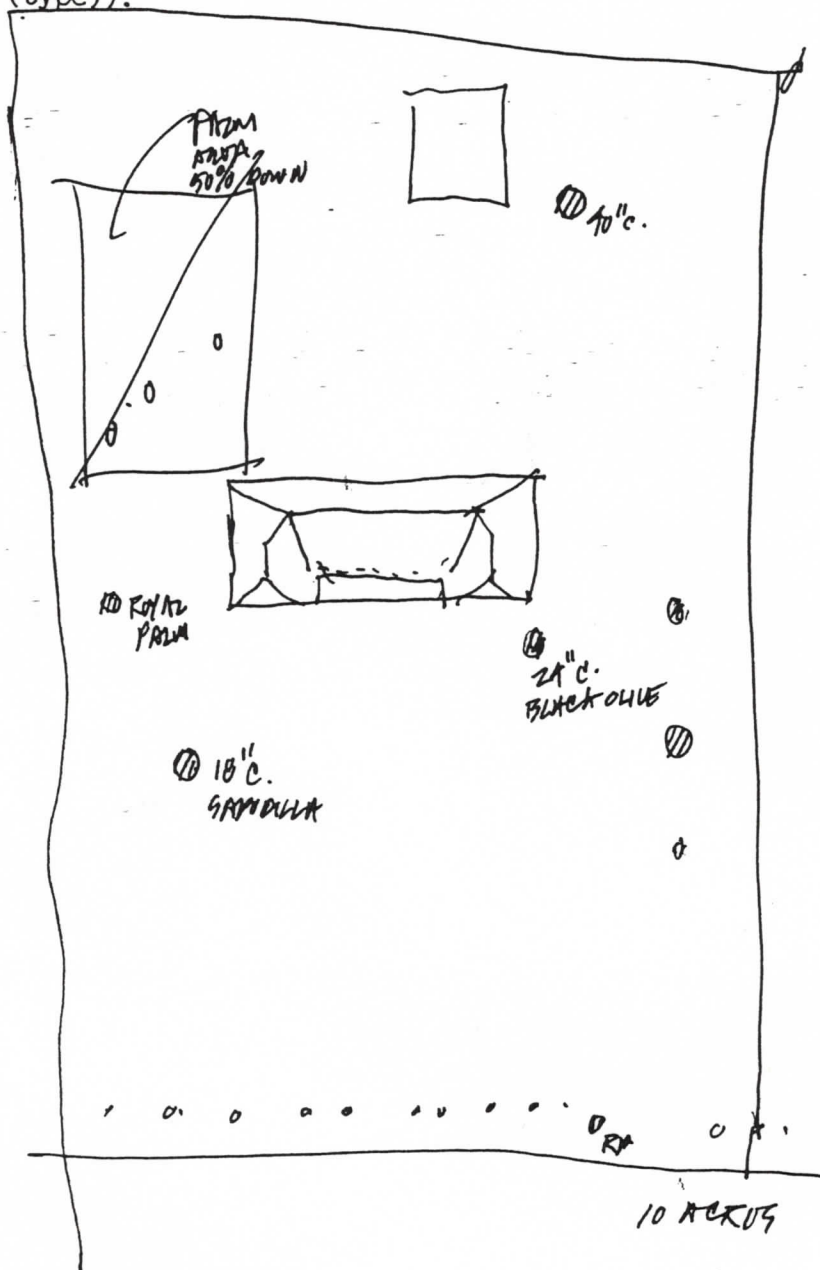
Site Sketch:

LANDSCAPE LOSS
INCLUDES MANY VARIETY OF PALMS
AVOCADO : MANGO
